FAA-NA-77-35

FAA/RD-77-13

# FULL-SCALE AIRCRAFT CRASH TESTS OF MODIFIED JET FUEL

Robert H. Ahlers

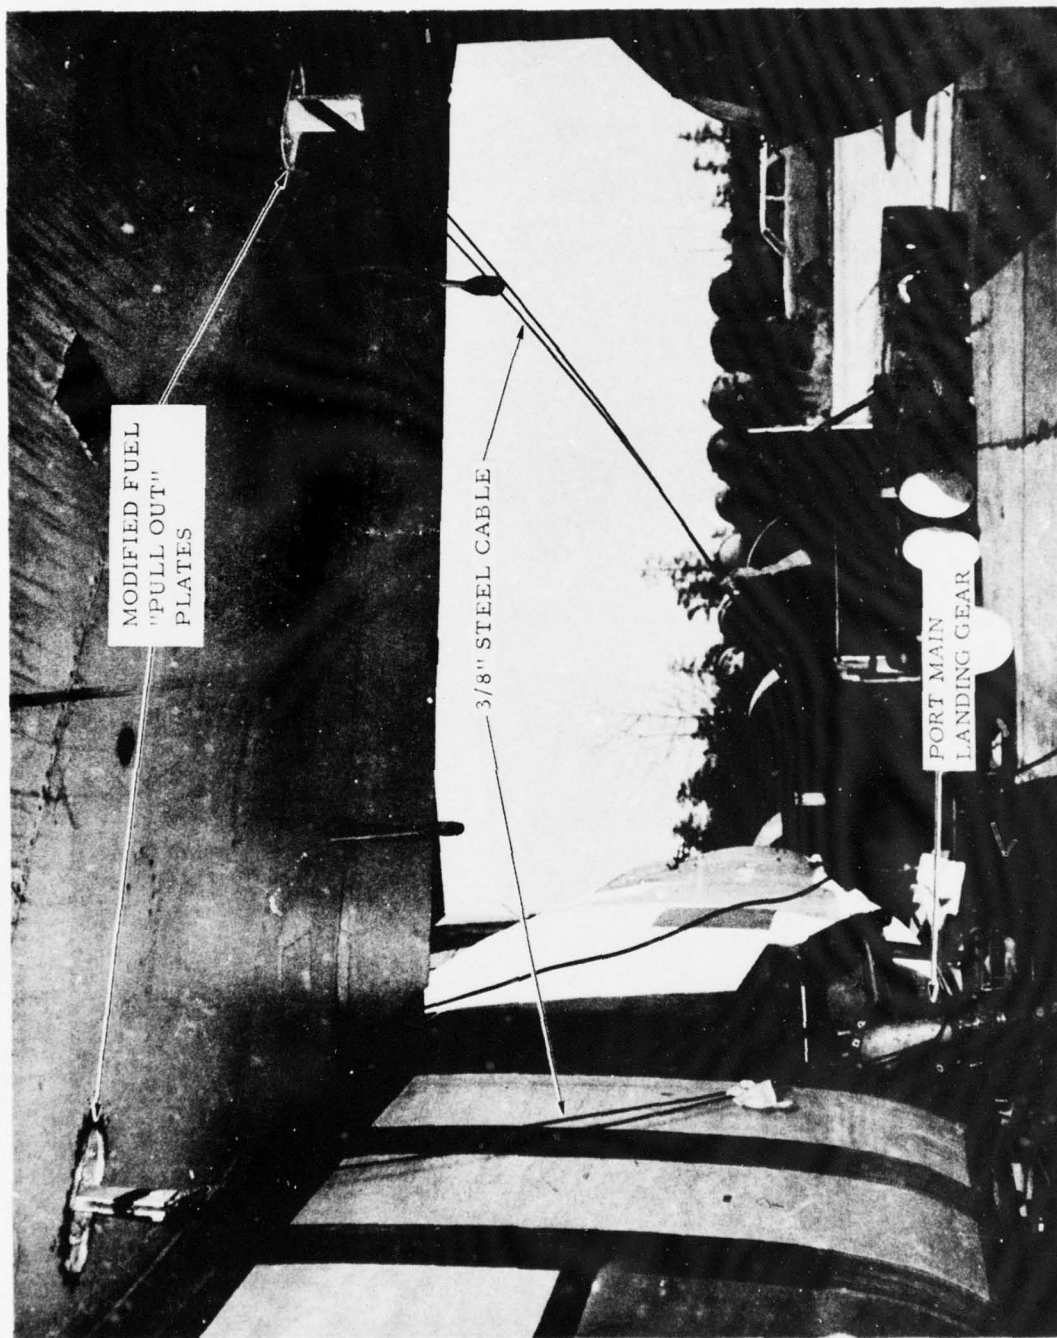
74-38-23

A special effort was made on this test to increase the quantity of fuel gushing from the wing tanks as the test airplane passed through the test site area. One scheme was to forcibly pull out two fuel tank inspection plates under each wing. Figure 21 shows the installation on the port wing. Heavy steel levers were welded to a modified inspection plate that had a weak membrane of thin aluminum, fabricated within its structure. The steel lever arm was connected to the main landing gear strut by 3/8-inch-diameter stainless steel cable, and during the actual test, when the landing gear was knocked off, the inspection plates were torn out of the wing tank skin allowing the fuel to escape. Figure 22 shows the underside of the wing after an inspection plate had been pulled out during the test.

FIGURE 21. FUEL TANK INSPECTION PLATE PULLOUT INSTALLATION

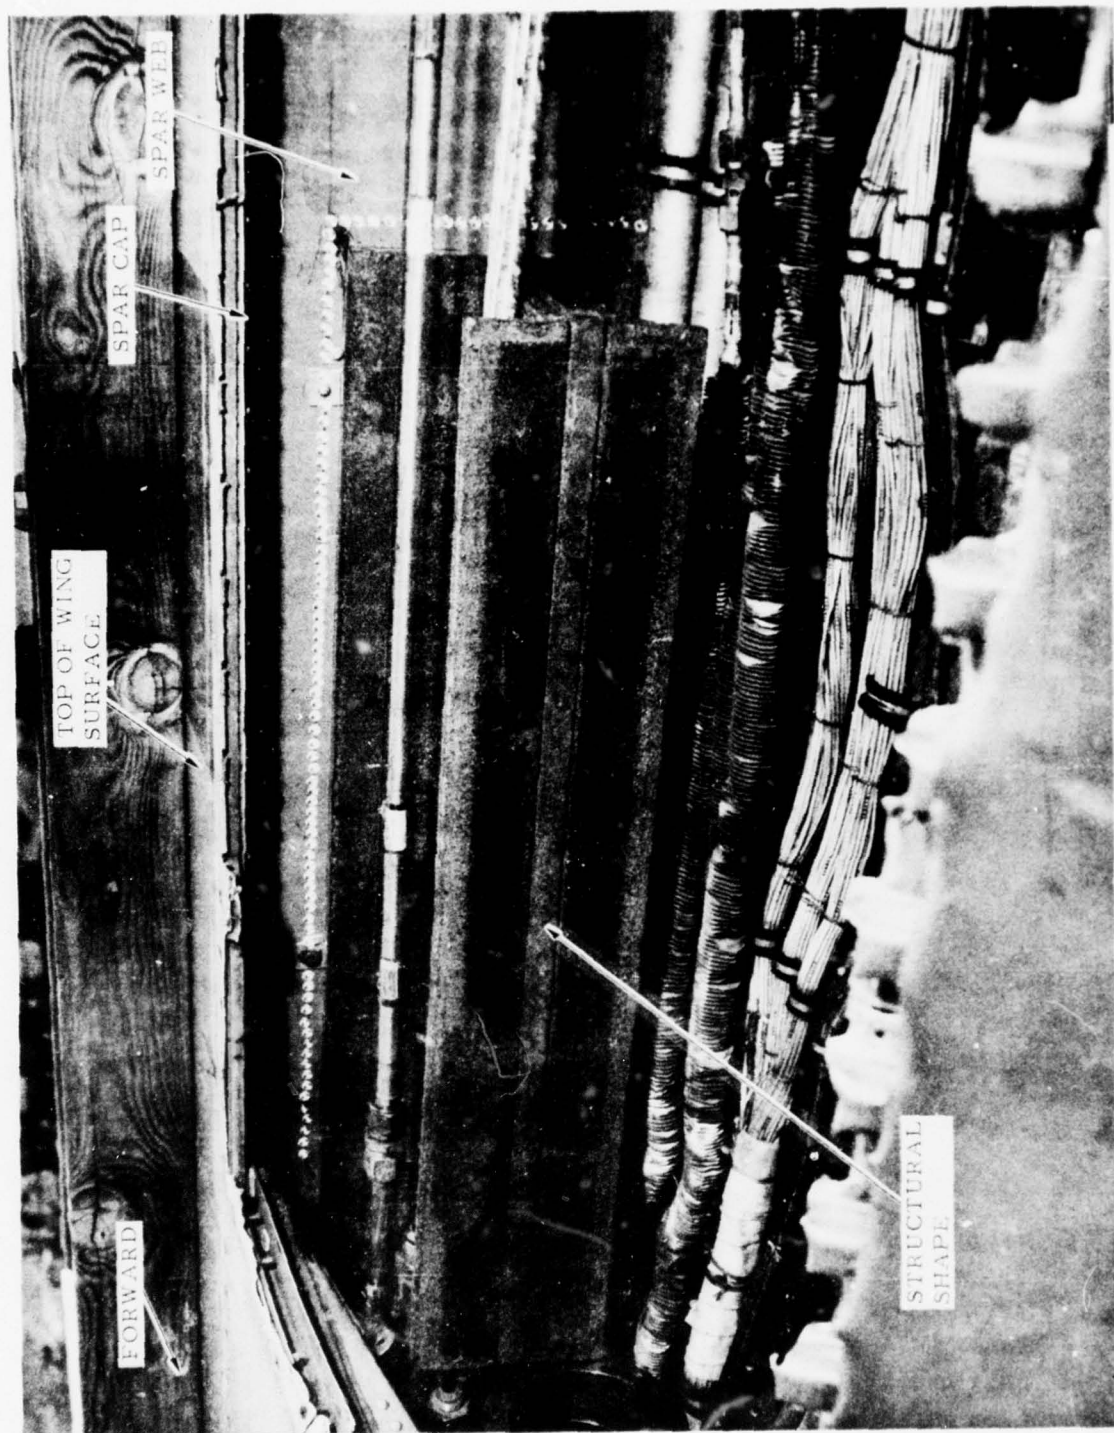
From the results of the previous tests, it was determined that the wing spar caps were protecting the spar web from damage when the wing leading edge contacted the telephone poles during the test. The wing spar web formed the front bulkhead of the integral wing tank, and if this web did not suffer structural failure, the fuel inside the tank would not be released. To increase the probability of failing, the spar web devices as shown in figure 23 were fabricated from structural iron shapes and located in the four positions of the wing leading edge that would contact the upright telephone pole obstacles in the test site area. The fabricated structural shape would be the first thing to contact the telephone poles and therefore would be driven through the spar web, thus rupturing the wing fuel tank. Figure 24 shows the type of structural failure that the wing tanks underwent during this test.

FIGURE 23. LEADING-EDGE MODIFICATION TO PRODUCE MORE SEVERE TANK RUPTURE

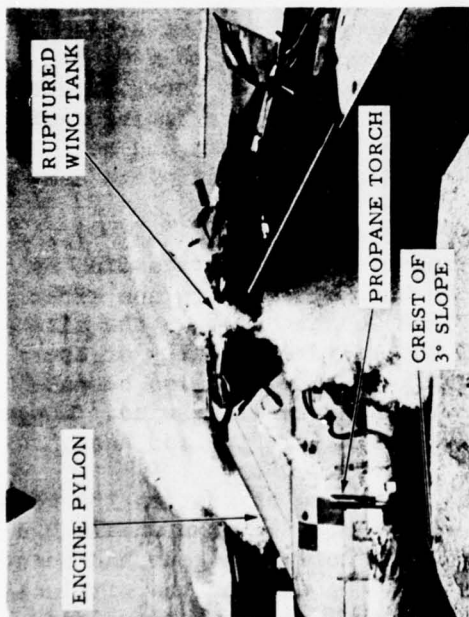
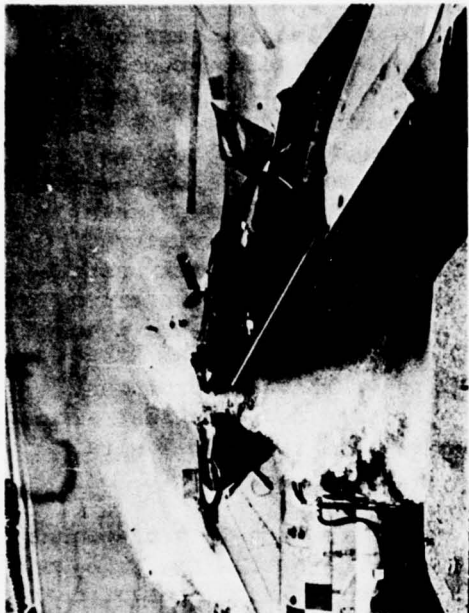
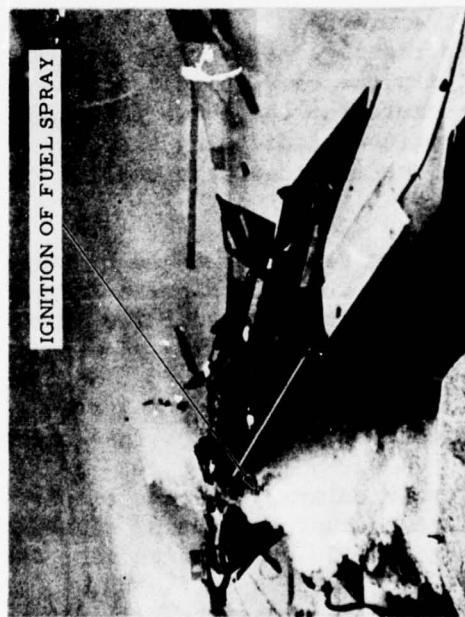
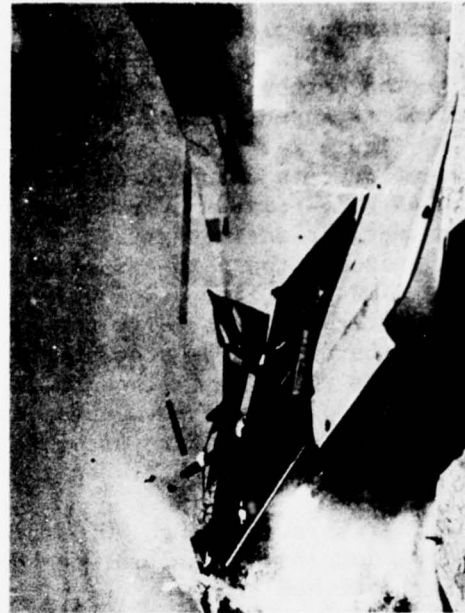
FIGURE 37. FUEL RELEASED DURING FULL-SCALE CRASH TEST
